# A Streamlining Remote Sensing and Digitalization Process for Bridge Inspection

ZHENHUA SHI, HAIBIN ZHANG, TARUTAL GHOSH MONDAL,  
BRYAN A. HARTNAGEL and GENDA CHEN

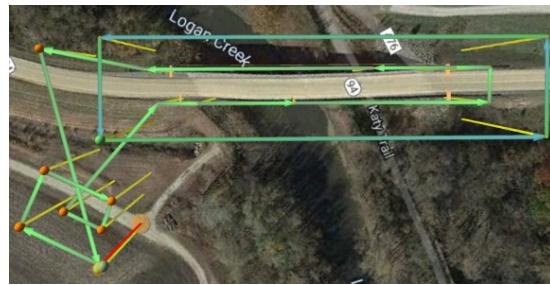
Figure 3. Autonomous flight path with sensor-trigger polygon

Figure 3 shows an autonomous flight path example for Missouri Bridge A4988 prepared in UgCS [17]. Planning the autonomous flight path takes into account the feature of interest and the minimization of direct flight over the traffic. The flight height is determined to avoid typical obstacles such as trees, powerlines, and utility poles. The flight height in Figure 3 is 40.5m AGL with a flight speed of 1.5m/s. The total number of waypoints is 16, with a total flight time of approximately 5min. Note that it is

recommended to have a safety factor (for example, 1.2) when designing the flight height, as the actual flight height may vary greatly from the design value. This is due to the low resolution of the digital elevation model (DEM) referenced as the ground elevation in the software. In the previous section of the mockup bridge study, the designed AGL flight height in UgCS is 16.2m, while the actual flight height is only 12.8m. The blueish lines in Figure 3 are the defined polygon where the hyperspectral sensor will be triggered, outside of which the sensor will be inactive. The flight path is designed along the wings of the bridge deck to minimize flying directly over the traffic. Depending on the maximum flight time of the UAS, the target resolution and specific bridge conditions (length, width, curvature, etc.), the flight height, path, and speed can be adjusted. The height is typically in the range of 30m-50m to overpass most obstacles and to minimize distractions to the traffic. The total flight time, which can be adjusted by flight speed and path, is usually kept within 15min (maximum: 18min) to have adequate time for a safe landing. For the flight paths underneath the bridge deck, Elios2 is flown in-between the girders to avert strong wind due to poor wind tolerance. Its collision-tolerance feature also comes in handy while navigating through narrow spaces. When it reaches the end of a span or the end of the entire bridge, the drone will be maneuvered into an adjacent girder channel and flown in the opposite direction. The flight path for bridge side inspection is to maintain a constant distance with the camera directly facing the bridge façade. A hand-held Nikon camera is used for drone-inaccessible areas such as bushy spans, dusty areas, tight space areas, and high-water level conditions.

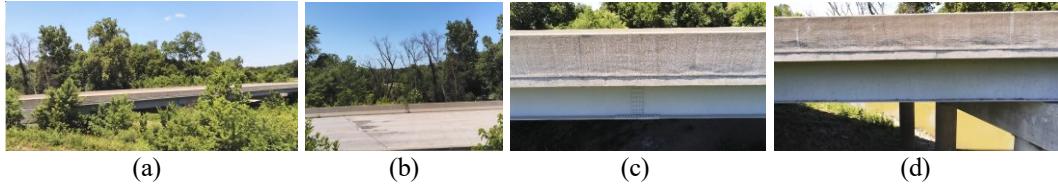
Figure 4. Representative images taken from Parrot

This section presents the inspection data for Missouri steel bridge A4988 (total length: 109m, four spans: 21m + 31m + 31m + 26m), each having five steel girders. Figure 4 shows several representative images collected by the Parrot drone, which is suitable for the bridge side and overall inspection. Although only the images are presented here, the drone captures videos during data collection. Figure 4(a) shows the drone view when it was approaching the bridge after takeoff. Figure 4(b) shows the drone view on the bridge deck when it was flown near the side of the bridge. Figure 4(c) shows a captured image of the bolted connection of the steel girder, while Figure 4(d) shows the image captured near one of the bridge bents. Parrot was flown parallel to the bridge deck to capture features of interest such as bridge joints, pier bents, and any noticeable deteriorations. For bushy areas where flying drones would be risky, a hand-held camera would be used. Figure 5 shows several images taken from a Nikon camera, which can also be used for high-priority areas. Figure 5(a) shows the image captured of bolted connections on the steel girder from the bottom, while Figure 5(b) shows the captured side view from the bottom side of the bridge. Figure 5(c) shows the bottom view of the bridge deck with piers for the span over the trail, while Figure 5(d) shows the bottom of the bridge deck and piers for the span over the creek. The investigated bridge was 19 years old at the inspection time and was generally in good condition.

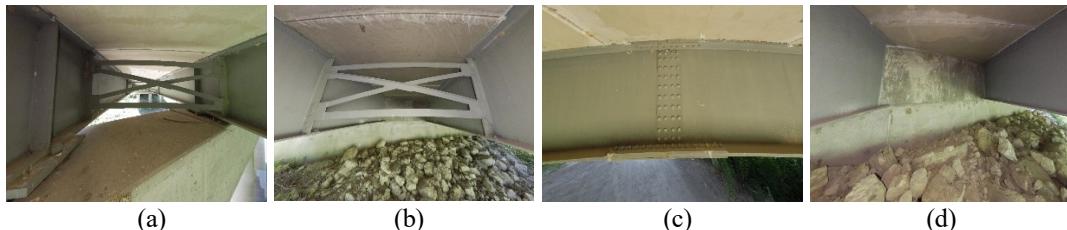
Figure 6. Representative images taken from Elios2 camera

Figure 6 shows several representative images of the bridge taken from Elios2, which is designed for confined space inspection. The flight path for Elios 2 is to follow the girder channel to inspect the bridge girders, underneath the bridge deck, and the top of the bridge bents. No paint corrosion on the girders was noticed. Figure 7 shows the thermal images taken by the FLIR camera to reveal possible delamination at the subsurface. Specifically, Figure 7(a) shows the location at the approach span where the joints and road surface patches can be clearly noticed. Figures 7(b) and (c) show the thermal images for the approach span and middle span, respectively. Figure 7(d) shows the thermal image for the other approach span with a squared tarpaulin used for hyperspectral reflectance calibration. Abrasions can be noticed near the joints. No other major damage was noticed for the bridge decks.
